# HIGHWAY RESEARCH REPORT

## Study of Lime Treated Sections on Road 10-SJ-580,132

**NO. M & R 633189**

A REPORT ON  
STUDY OF LIME TREATED  
SECTIONS ON ROAD  
10-SJ-580,132  
NEAR TRACY, CALIFORNIA

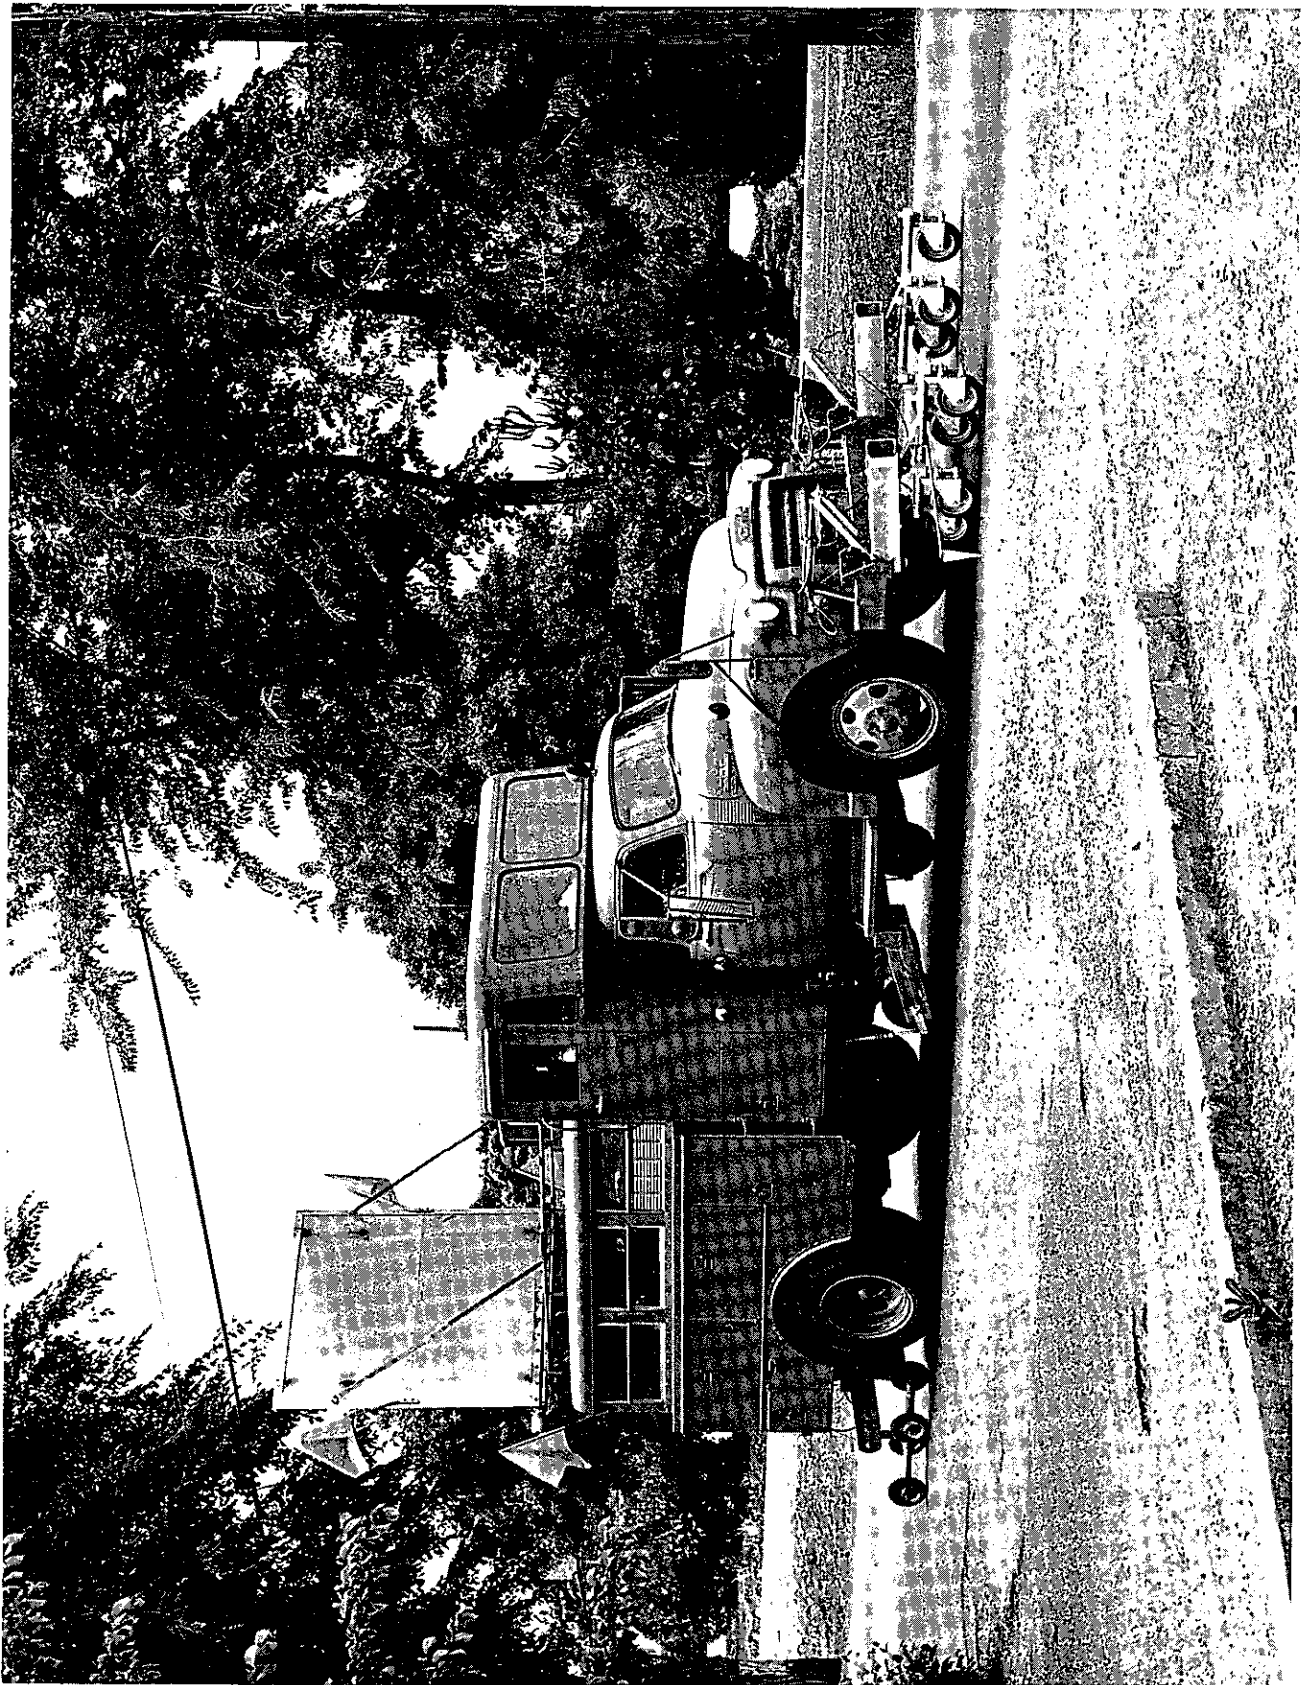
Figure 9

Initial profilograph measurements were made on the road about two months after the paving was completed. The California truck-mounted profilograph was used to make the measurements (Figure 9).
